GEOTECHNICAL/GEOPHYSICAL EVALUATION OF KARST LIMESTONE SITES – A CASE HISTORY

*Gregory B. Byer**, *Prism GeoImaging, Inc., Fishers, IN*
John A. Mundell, *Mundell & Associates, Inc., Indianapolis, IN*
*John H. M. Vanderlaan**, *Prism GeoImaging, Inc., Indianapolis, IN*

Abstract

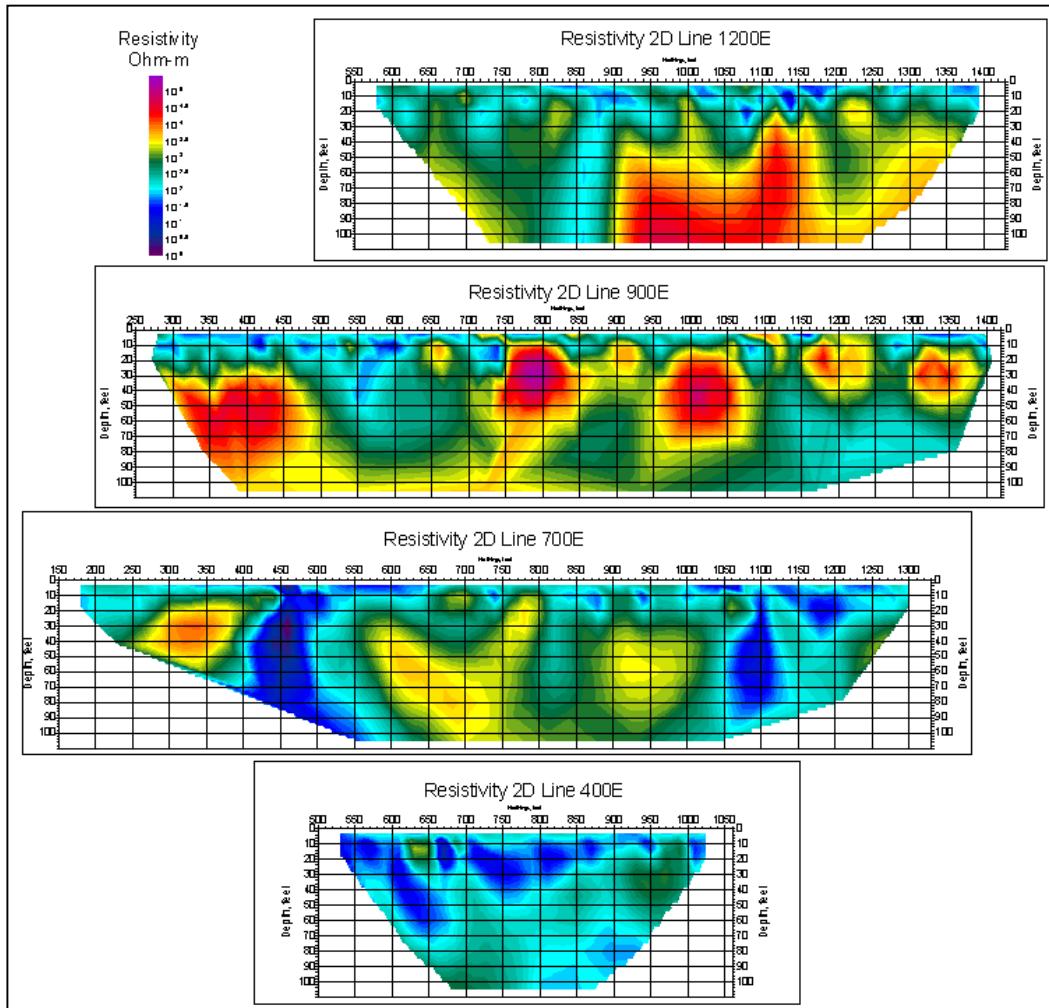
Figure 4. The four 2-dimensional resistivity profiles. The dipole-dipole array data were modeled using RES2DINV. The color scale used is lognormal ranging from dark blue for low resistivity through red and purple for very high resistivity. The low resistivity areas, dark blue to cyan, were interpreted as mainly soils. High resistivity, yellow to red to purple, was interpreted as limestone bedrock. It is also possible that air filled voids could be present, and they too would have high resistivity. The extreme range of resistivity values (5 orders of magnitude) suggests that significant overshoot in the modeling has occurred. Later downhole logging would indicate there are about two orders of magnitude of resistivity variation (about 10^1 to 10^3 ohm-meters).

The 2-dimensional resistivity data were acquired in the dipole-dipole array mode for all four cross sections. The apparent resistivity data were modeled using RES2DINV. The results of the 2-dimensional resistivity modeling for the four lines were plotted as 1:1 resistivity cross sections presented in Figure 4. Line 1200E was later remodeled (Figure 7) after additional field investigation was concluded. The downhole logging would later show that the range of resistivity variation at the extreme was about two orders of magnitude (10^1 to 10^3 ohm-meters).

The four resistivity cross sections (Figure 4) are modeled from apparent resistivity data collected in the dipole-dipole array mode. The model solutions are only an approximate representation of the subsurface as they are a 2-dimensional representations of complex 3-dimensional structures. Since electrical current will follow the path of least resistance, distortions may be created by low resistivity features outside the plane of data collection. Additionally, the resolution of this method decreases with depth in an exponential fashion. The highest resistivity reflects the presence of competent rock that is low in moisture and relatively massive (yellow to red, 1000's ohm-meters). Weathered, fractured bedrock is more likely to be dark green to yellow (100's to 1000's ohm-meters). Residual soil will vary from deep blue, light blue, light green, to dark green (10's to 100's ohm-meters) depending on moisture content. Air filled voids may appear as high resistivity levels as well.

In general, the shape of the bedrock surface appears to be very irregular along Lines 700E, 900E, and 1200E. Several locations indicate weathering may have extended very deep into rock (See for example Line 700E at stations 800-850N, Line 900E stations 500-700N, and Line 1200E stations 800-900N). A number of other examples of this complex weathering pattern exist across the site.

Weathering appears to go deep in the sinkhole area on the southeastern corner of the Site as was expected (see Line 1200E, station 580 to 900N). Within this zone overhangs and pinnacles are possibly indicated. Again on Line 1200E, a deeply weathered zone is apparent from 1200N to 1250N. Lines 700E and 900E have several areas where potential karst features are indicated at depth.

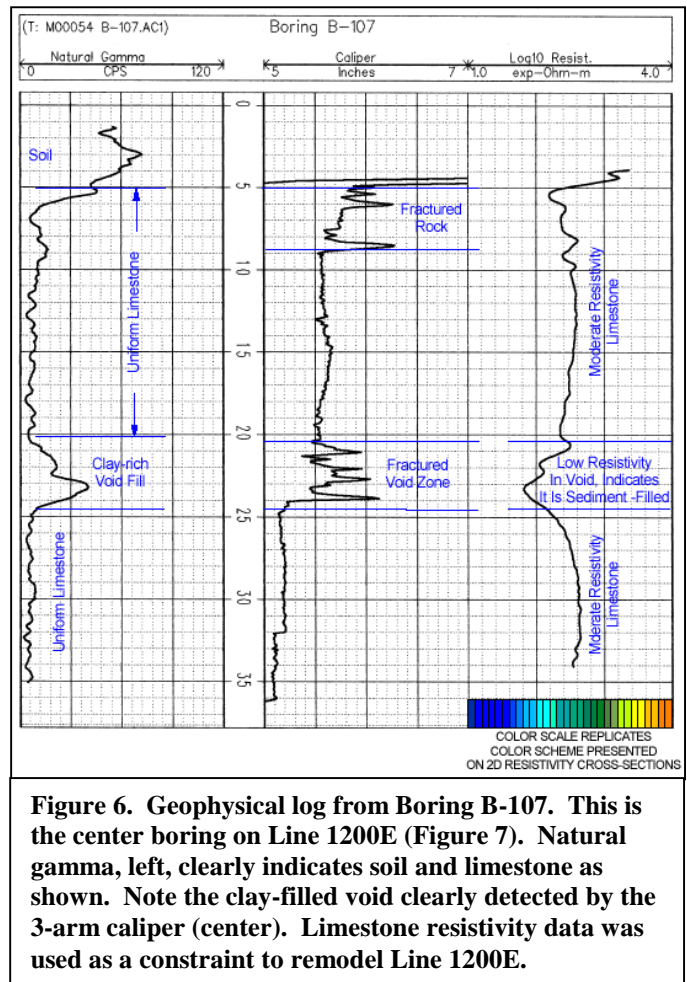
Figure 6. Geophysical log from Boring B-107. This is the center boring on Line 1200E (Figure 7). Natural gamma, left, clearly indicates soil and limestone as shown. Note the clay-filled void clearly detected by the 3-arm caliper (center). Limestone resistivity data was used as a constraint to remodel Line 1200E.

Auger and air percussion drilling were completed to provide direct access to the soil and bedrock for geophysical logging purposes. Geophysical logging was conducted in seven of the eight open borings shown on Figure 5 to provide not only accurate lithologic and depth-to-bedrock information, but also to provide 1) in-situ electrical resistivity data for calibration with existing surface geophysical data and 2) the locations and characteristics of fractures and voids. Three types of borehole geophysical logging were performed: natural gamma, electromagnetic conductivity, and three-arm caliper. These methods provided information about the lithologic conditions, existence of fractures and voids, and electrical resistivity readings for calibration with surface geophysical data. An example of one of the borehole geophysical logs from Boring B-107 is provided (Figure 6). The information from the geophysical logs was used to:

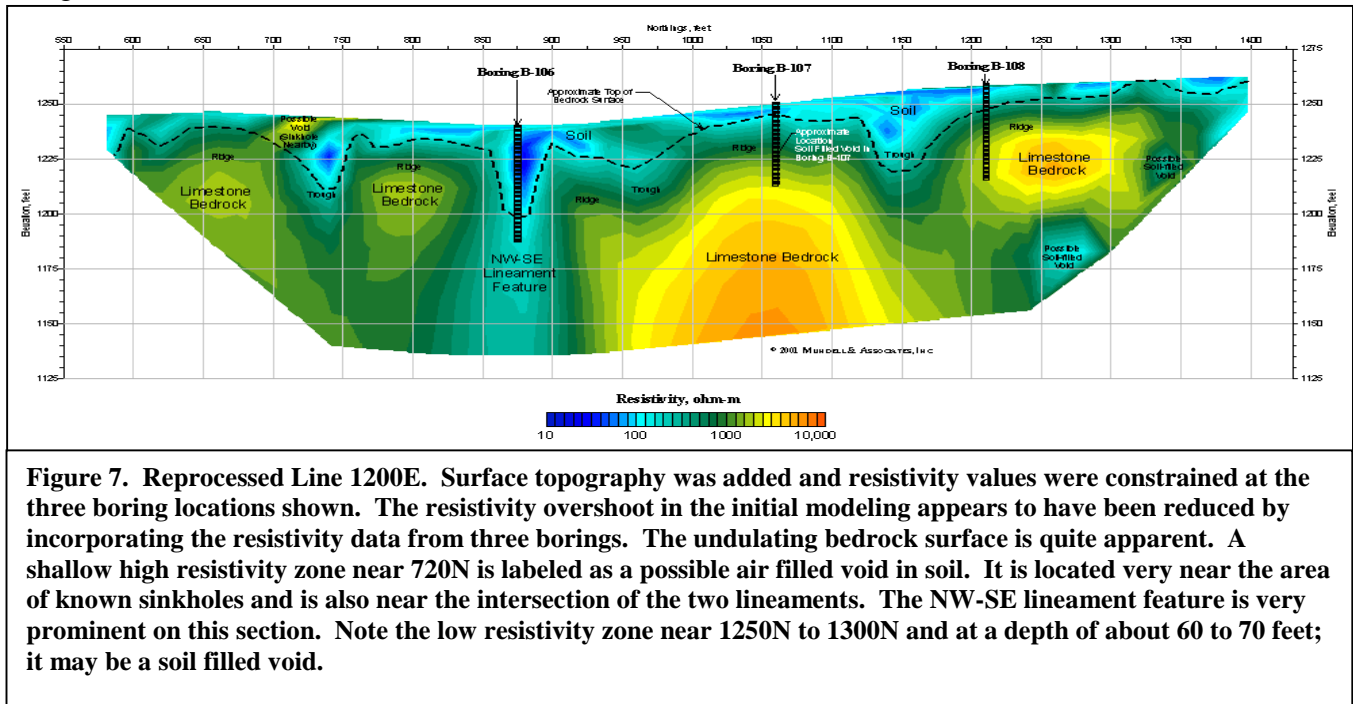
Line 1200E (Figure 7) was reprocessed to include the topographic data and was constrained using the three new borehole resistivity logs (B-106, B-107, and B-108) as shown on Figure 7. The geophysical logging indicated about two orders of variation in resistivity (10^1 to 10^3 ohm-meters). This new information helped subdue the severe modeling overshoot present in the initial, unconstrained resistivity data. Annotation was added to Line 1200E indicating a reasonable degree of confidence in the location of the top of bedrock, structural features (such as the NW-SE Lineament), ridges and troughs, and air or soil filled voids.

limestone blocks is very apparent. This fabric is clearly shown on the EM-34 resistivity map on Figures 3 and 5. This fabric consists of alternating high resistivity and low resistivity anomalies. The pinnacles and grikes are also annotated on Line 1200E (Figure 7).

The limestone bedrock blocks are divided in the center of the site and are bounded on the south end of the site by lineament features. The more regionally significant of the two lineaments is the NW-SE (northwest-southeast) Lineament shown in red crosshatch on Figure 8. This feature is clearly depicted both on the EM-34 resistivity map (Figures 3 and 5) and the 2-D resistivity cross-section (Figure 7).

The transition zone between the lineament features and the bedrock blocks appears to be a complex, highly variable weathered zone. This overlap zone is the target for potential concern regarding the formation of karst features including voids. In this zone, the process of chemical weathering is interpreted to have had the potential to invade the bedrock laterally along the lineament sidewalls where it had access from the deeply weathered lineament zones. The drilling in these overlap zones, although limited in scope, did discover one relatively small void (Boring B-107, Figure 6). This void was about two feet in thickness and was filled with soil. Other soil-filled voids may be present in these zones as suggested by two labeled soil-filled voids shown on Figure 7 between the Northings of 1250N and 1350N.
